Low-speed impact on structural integrity of aluminum alloy Al1050

Majid Hamed Al-Nabhani^a, Mohammad Sayeed Hossain^{a*} and Khaled Giasin^b

^aDepartment of Aeronautical Engineering, Military Technological College, Al Mater Street, PO Box 262, PC 111, Seeb, Muscat, The Sultanate of Oman

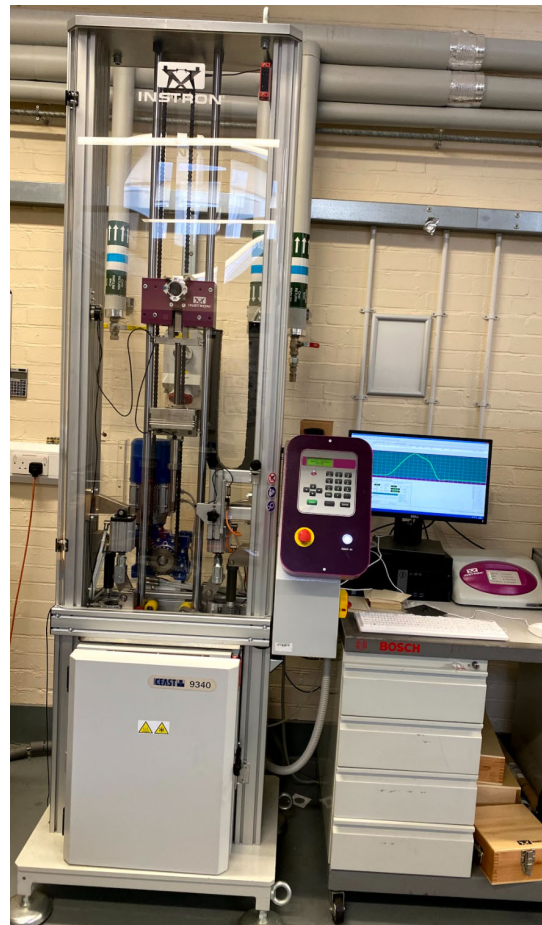
Fig. 1. CEAST 9340 drop weight impact machine developed by INSTRON® used in experimental tests

Low-velocity impacts, typically ranging from 1 to 10 m/s, were simulated in the laboratory using a CEAST 9340 drop hammer impact machine. The CEAST9340 drop hammer allows impacts to be conducted at different temperatures and impact energies with different impact hammer masses (punch mass). The well-known relation between kinetic energy, mass, and velocity $E = \frac{1}{2}mv^2$ can be used to find the desired parameter required for the test machine. The CEAST9340 (Fig. 1) allows for impacts at different temperatures and energies, with variations in impact hammer falling height. The experiment carried out in the lab involved impacting 27 Al1050 samples with three impact energies (40J, 80J, 120J) under a variety of temperatures (25°C, 70°C, 100°C) to investigate the impact behavior under low velocity impact.
